# Manhole Inspection Summary

Manhole # S53C\_\_054MH

Insp Date: **6/19/08 2:00 PM**

**Location** Address: **rear 4 n clinton st**

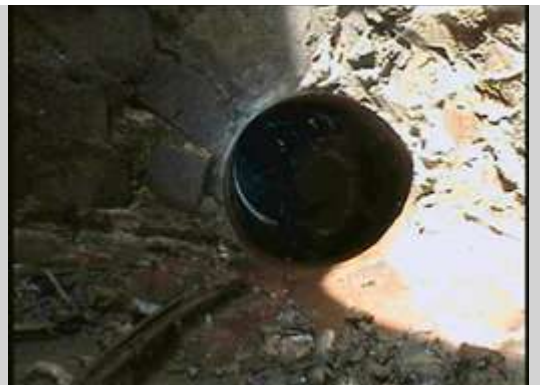
12 O'Clock Outflow

8 in. Circular Gravity Sewer  
Pipe Out @ 12 O'Clock

Infiltration: **None** Pipe Seal Cond: **Unknown**
